ANGKOR VAT

INDIA'S CONTRIBUTION IN CONSERVATION

MEMOIRS OF THE
ARCHAEOLOGICAL SURVEY OF INDIA
NO. 91

B. NARASIMHAIAH

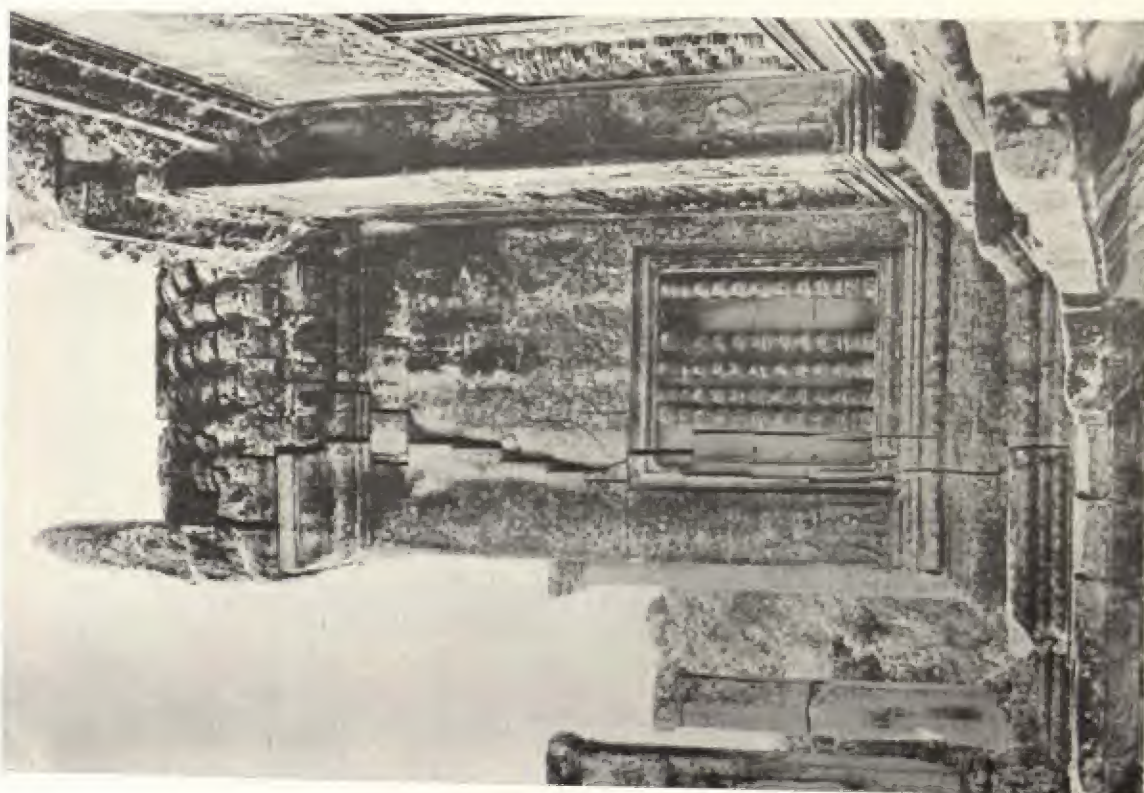
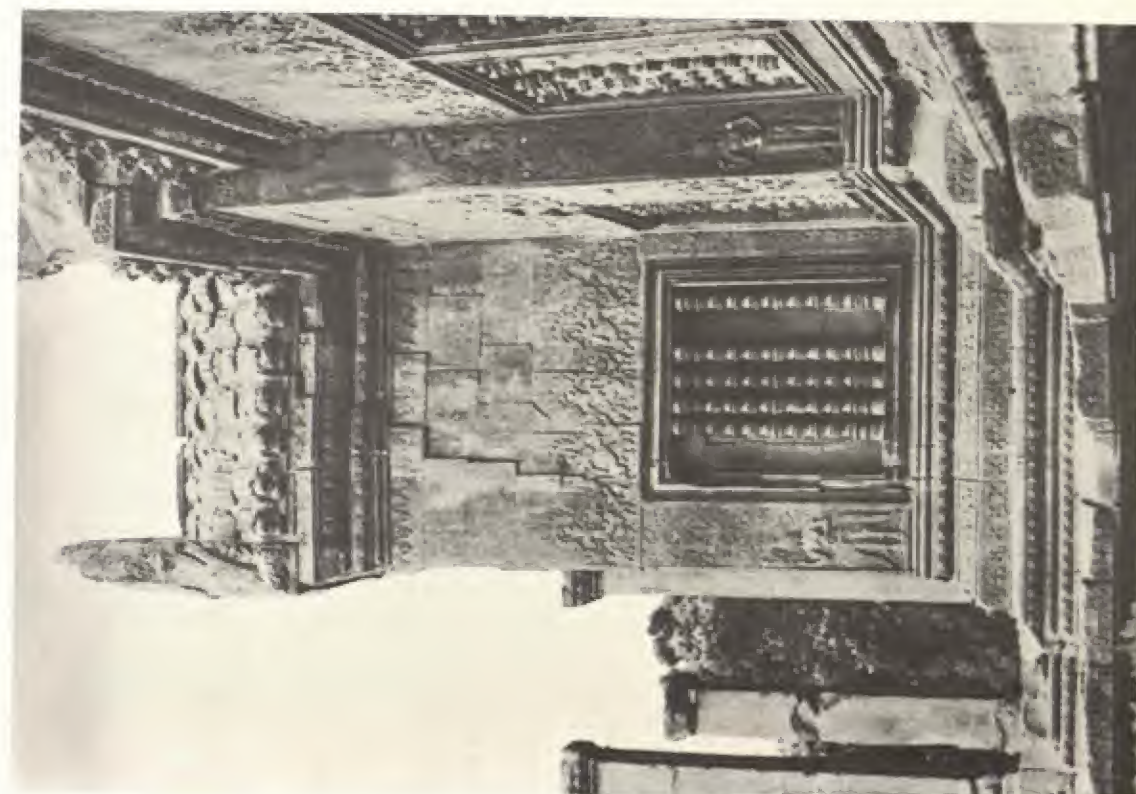
Fourth Enclosure, Western Gateway : torana of an entrance pavilion; A, before and B, after conservation

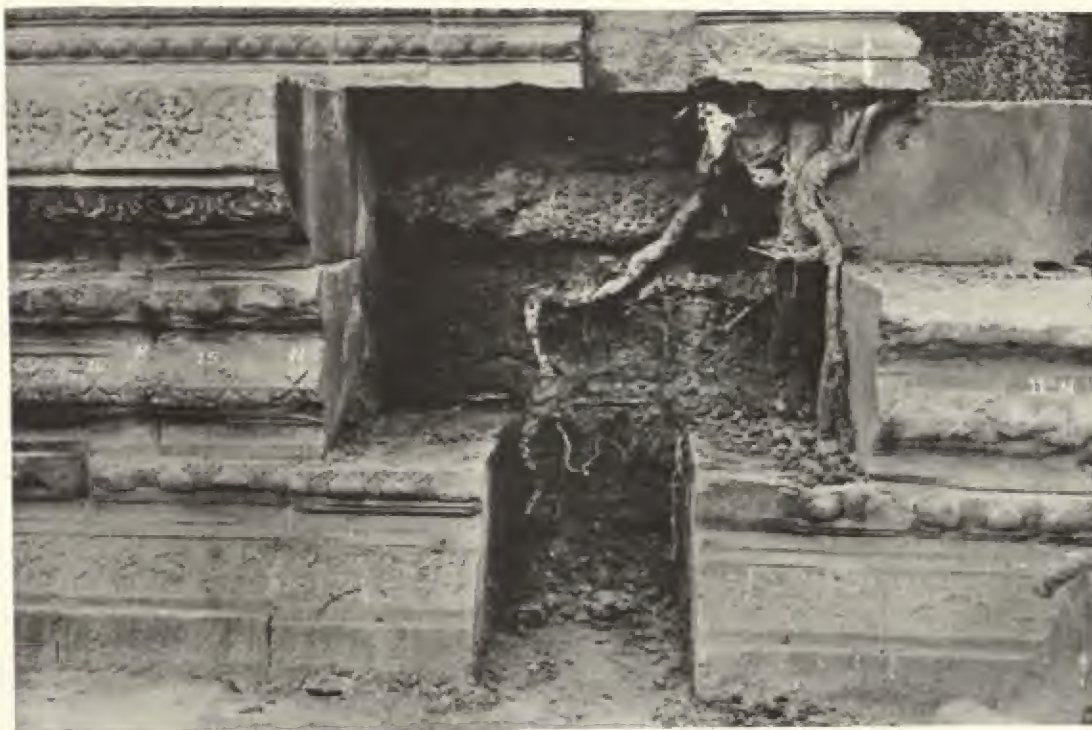
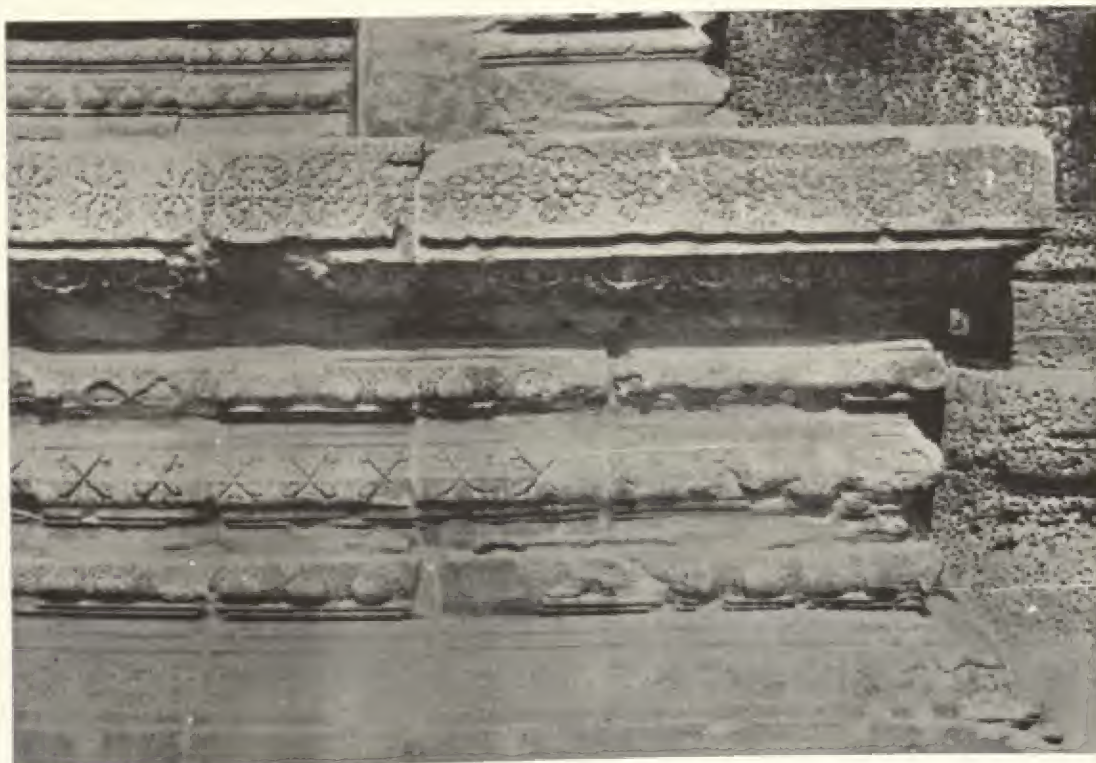
Fourth Enclosure, Western Gateway : plinth of southern elephant gate; A, before and B, after conservation

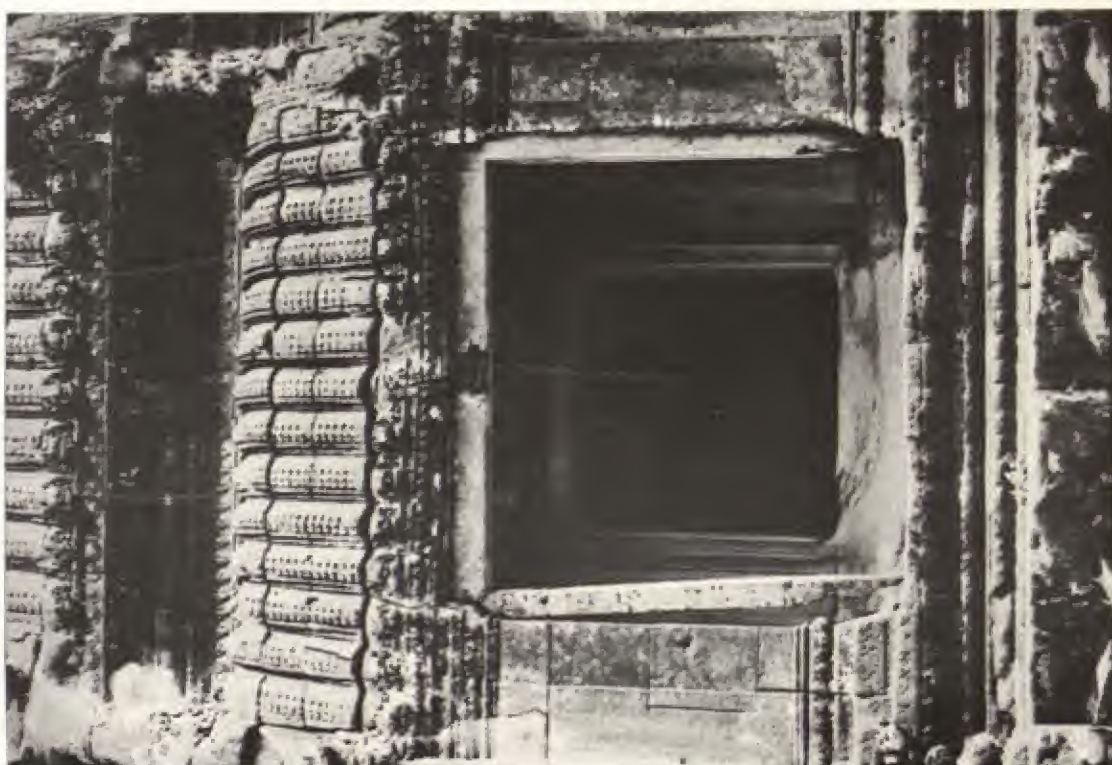
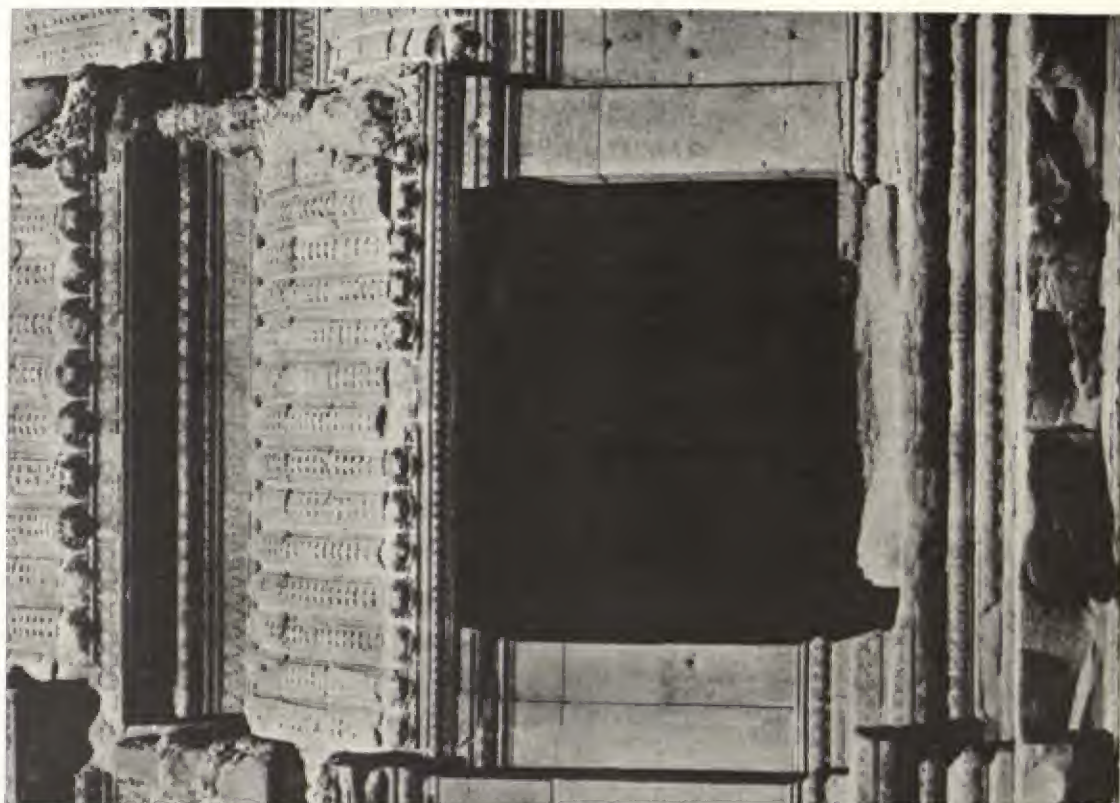
Fourth Enclosure, Western Gateway: beam of semi-vaulted roof. A, before and B, after conservation

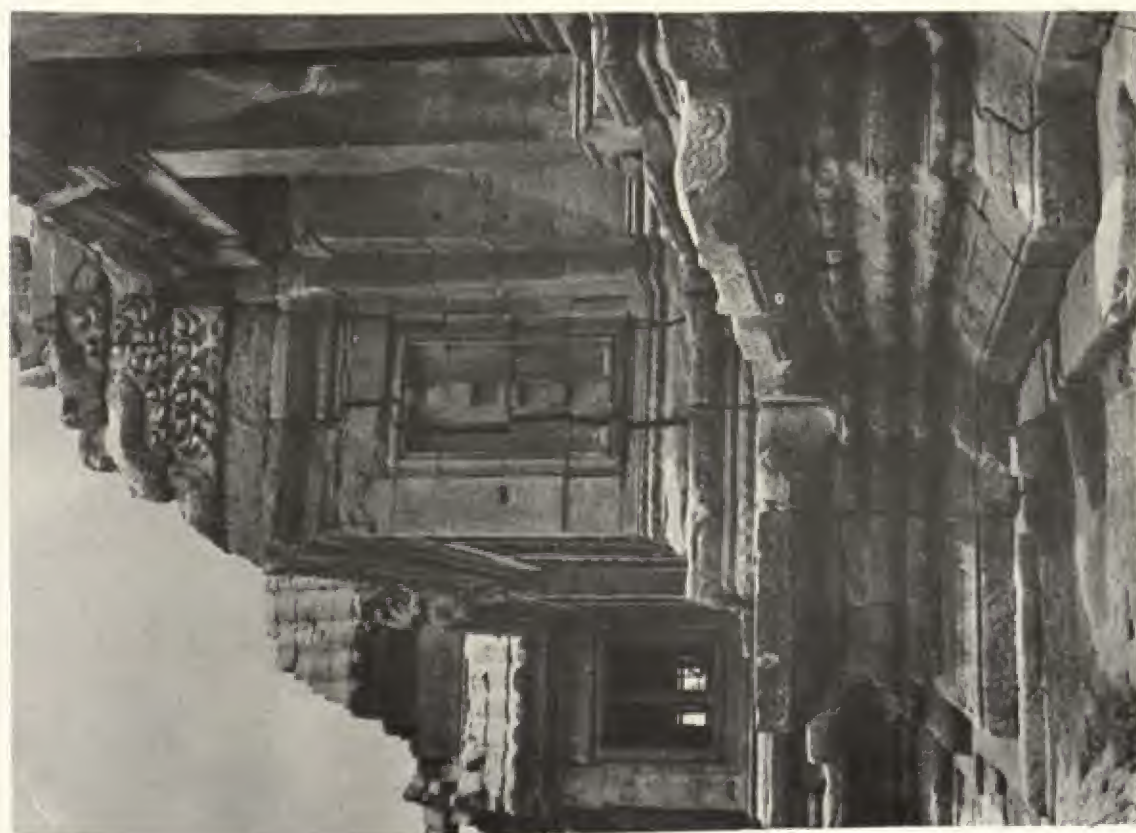
A

Southern Library between Third and Fourth Enclosures : false window on the western façade, A, before and B, after conservation

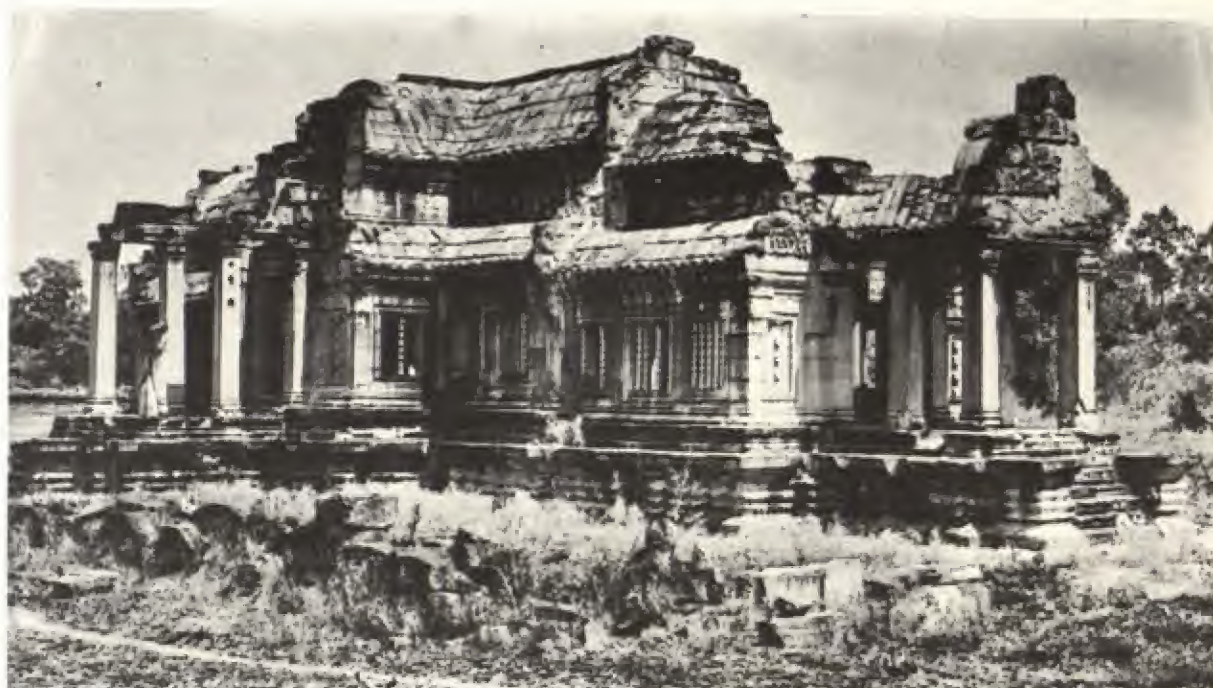
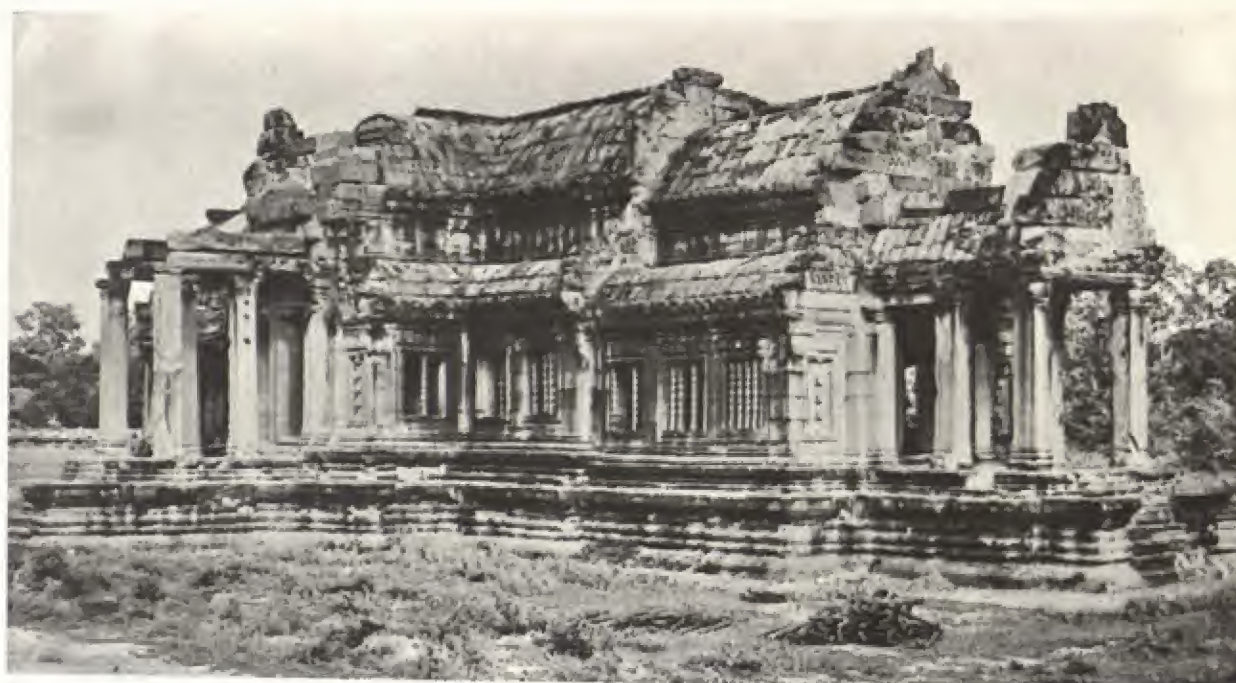
Southern Library between Third and Fourth Enclosures : western mandapa (pavilion), A, before and B, after conservation

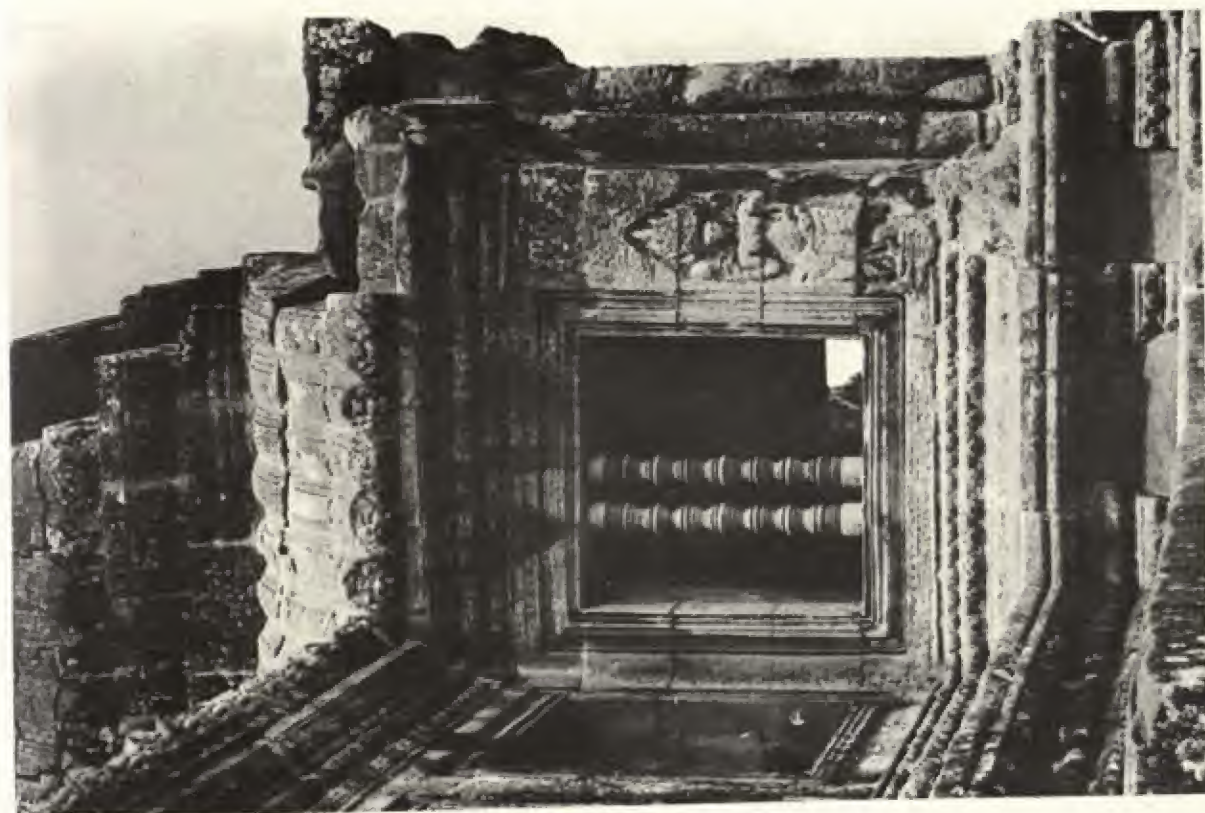
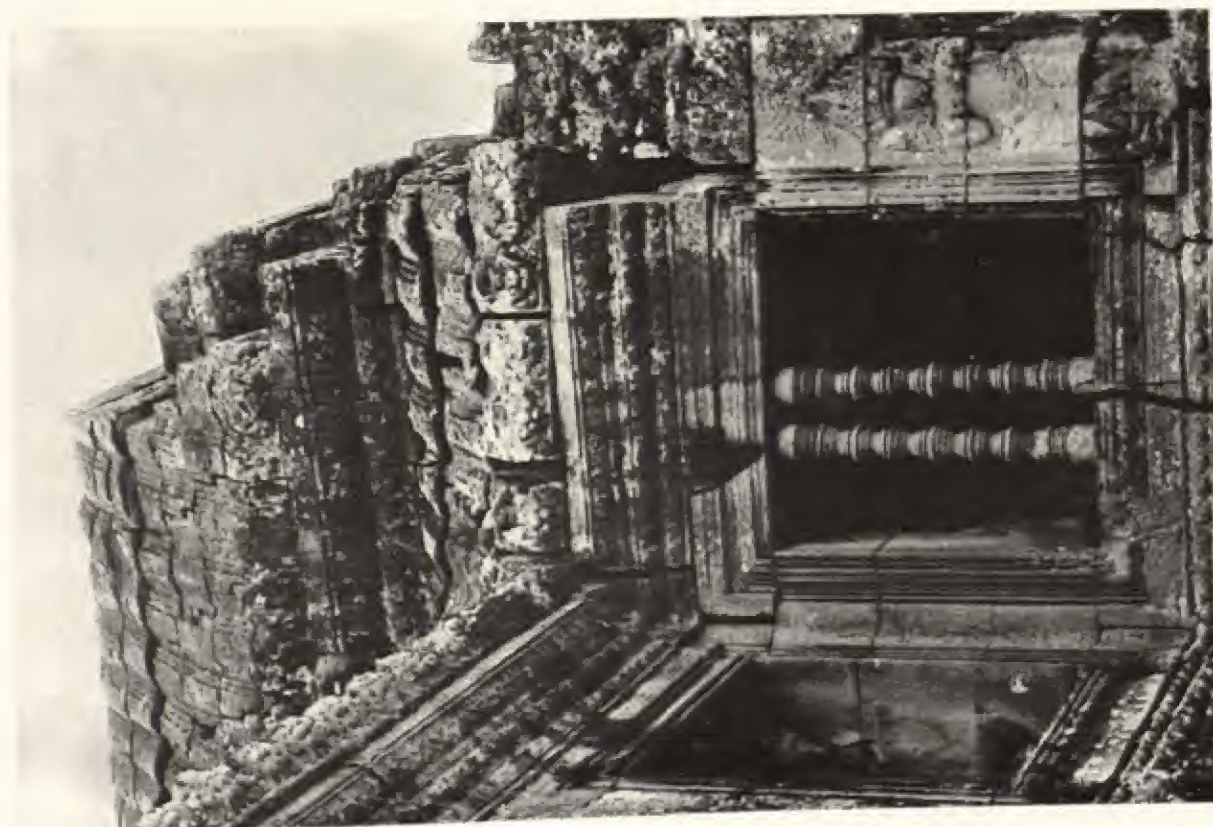
Northern Library between Third and Fourth Enclosures : verandah with semi-vaulted roof at north-eastern corner, A, before and B, after conservation

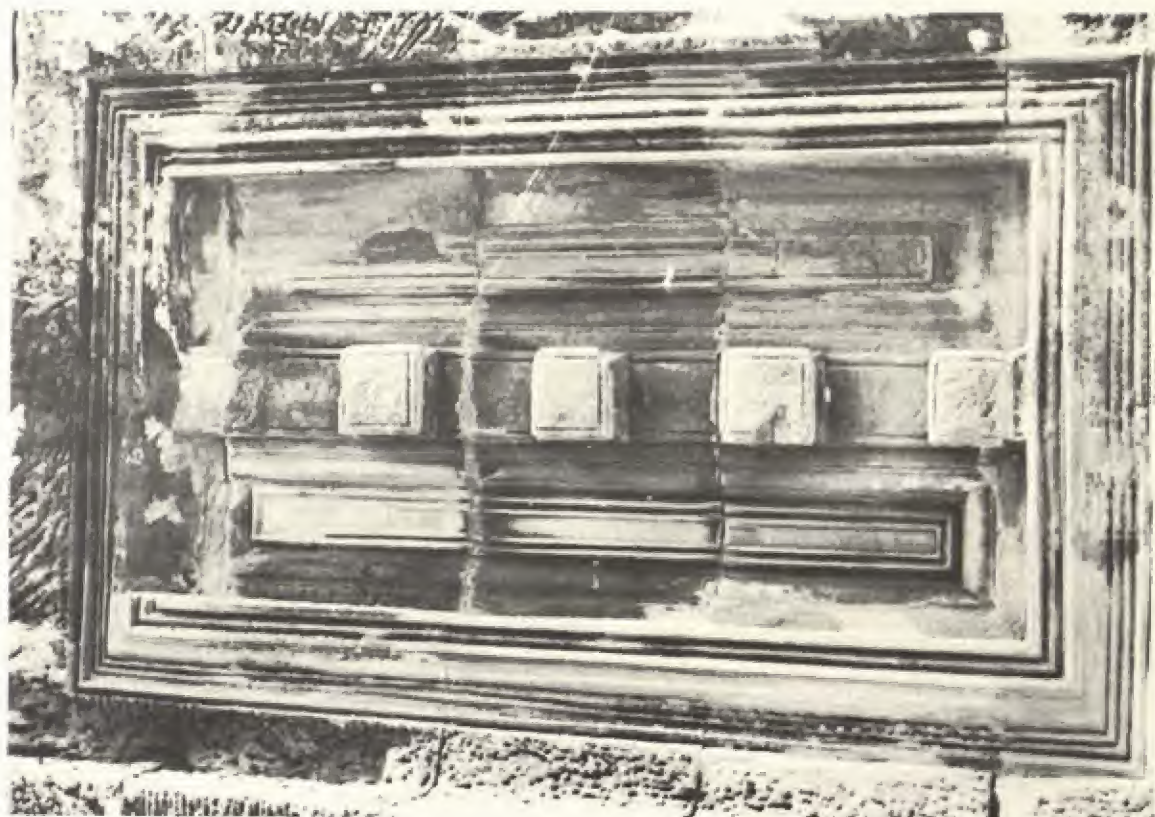
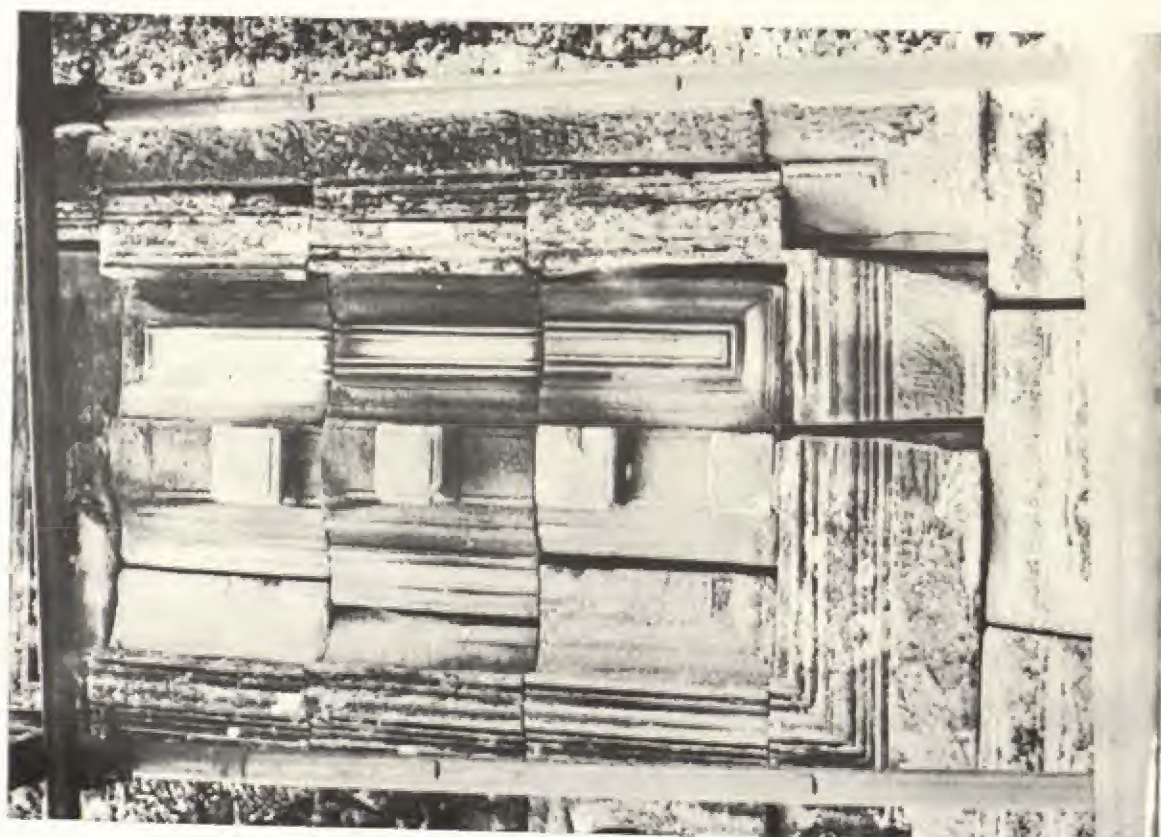
Northern Library between Third and Fourth Enclosures: false window, A, before and B, after conservation

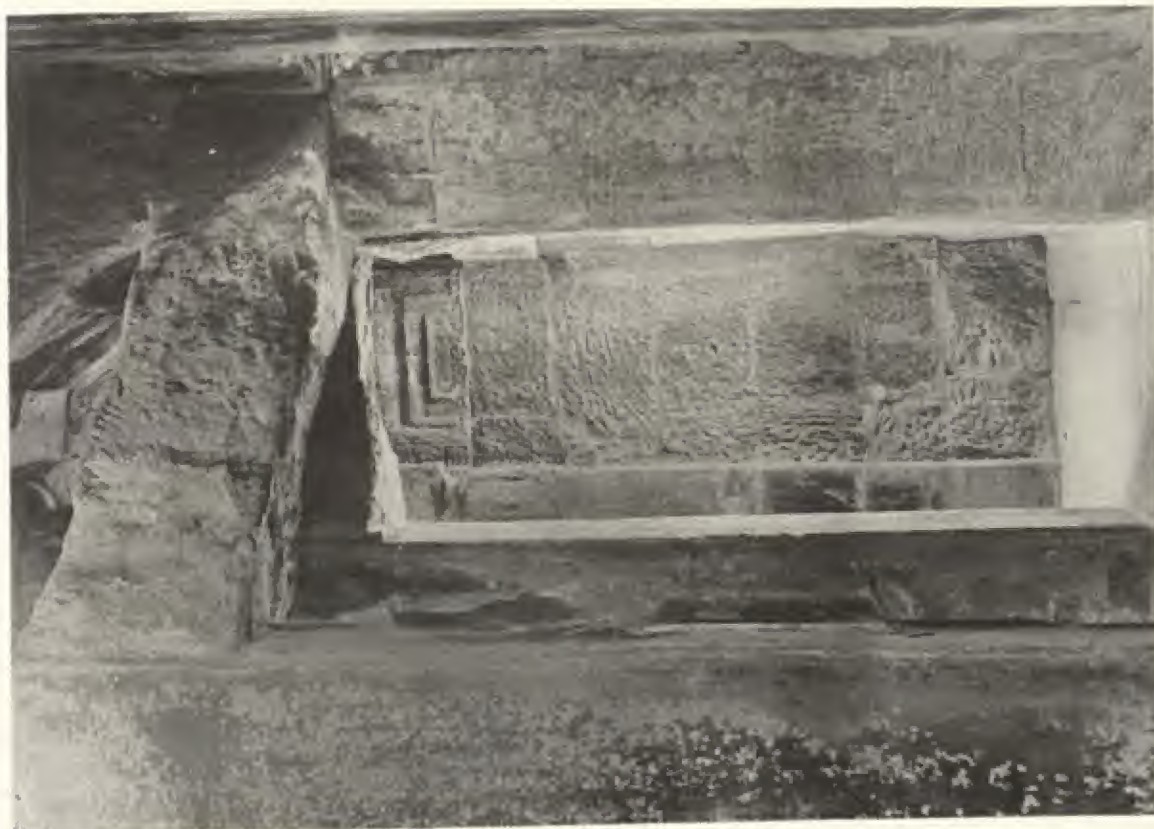
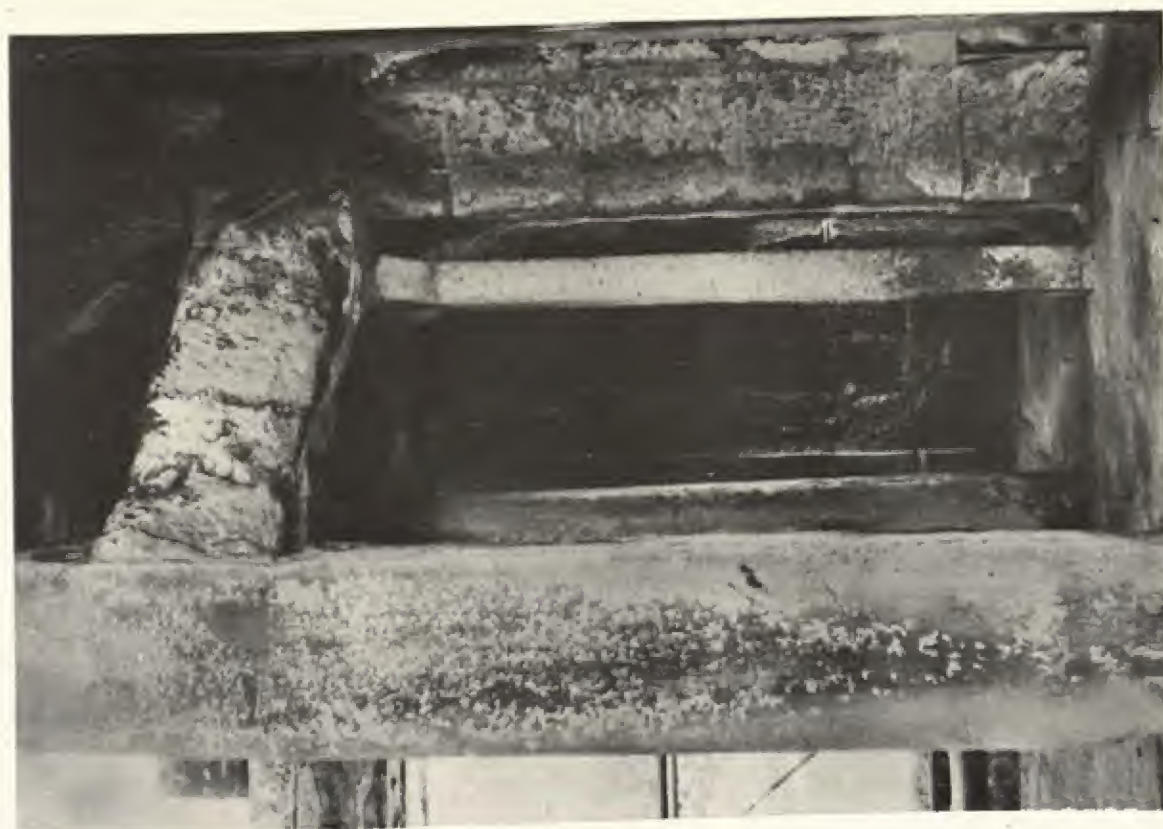
Northern Library between Third and Fourth Enclosures : tie-beam of the verandah. A, before and B, after conservation

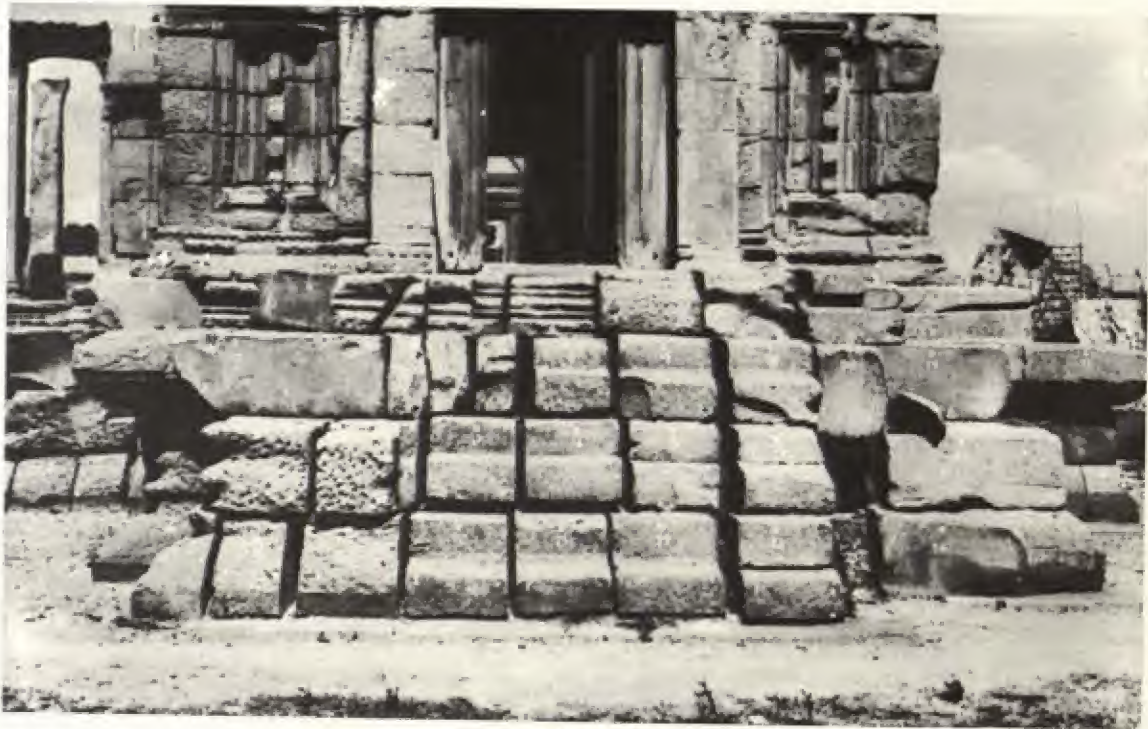
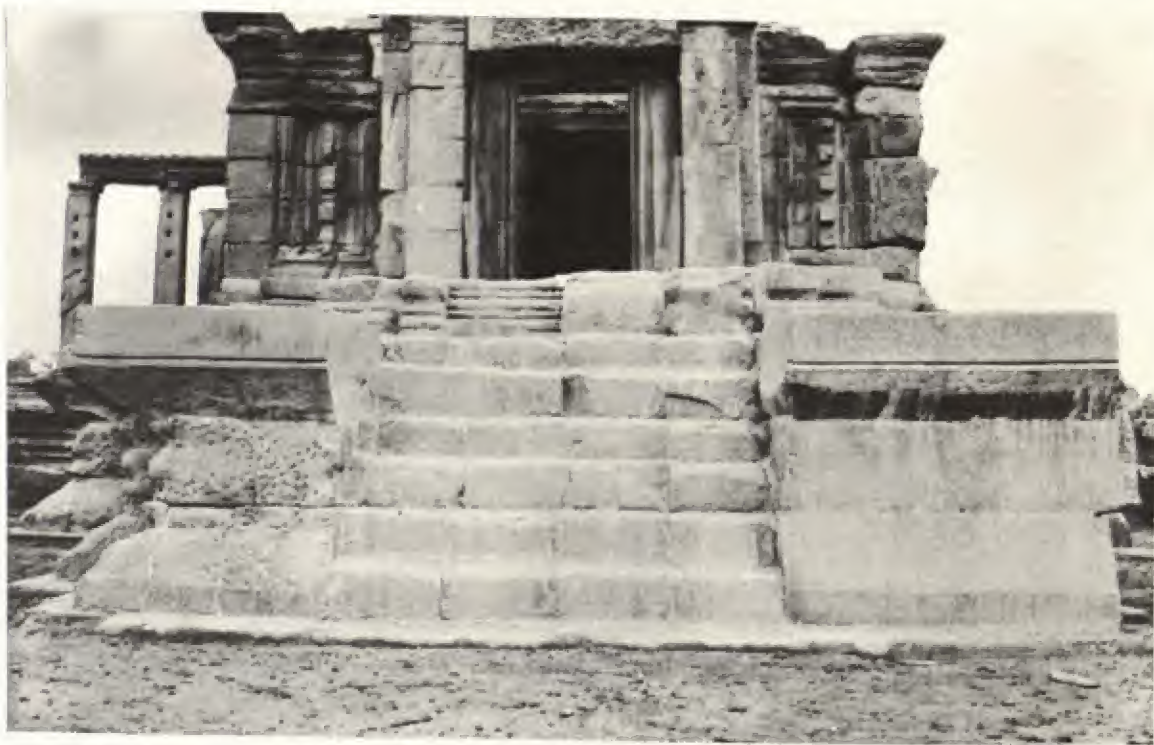
Northern Library : stepped entrance, A, before and B, after conservation

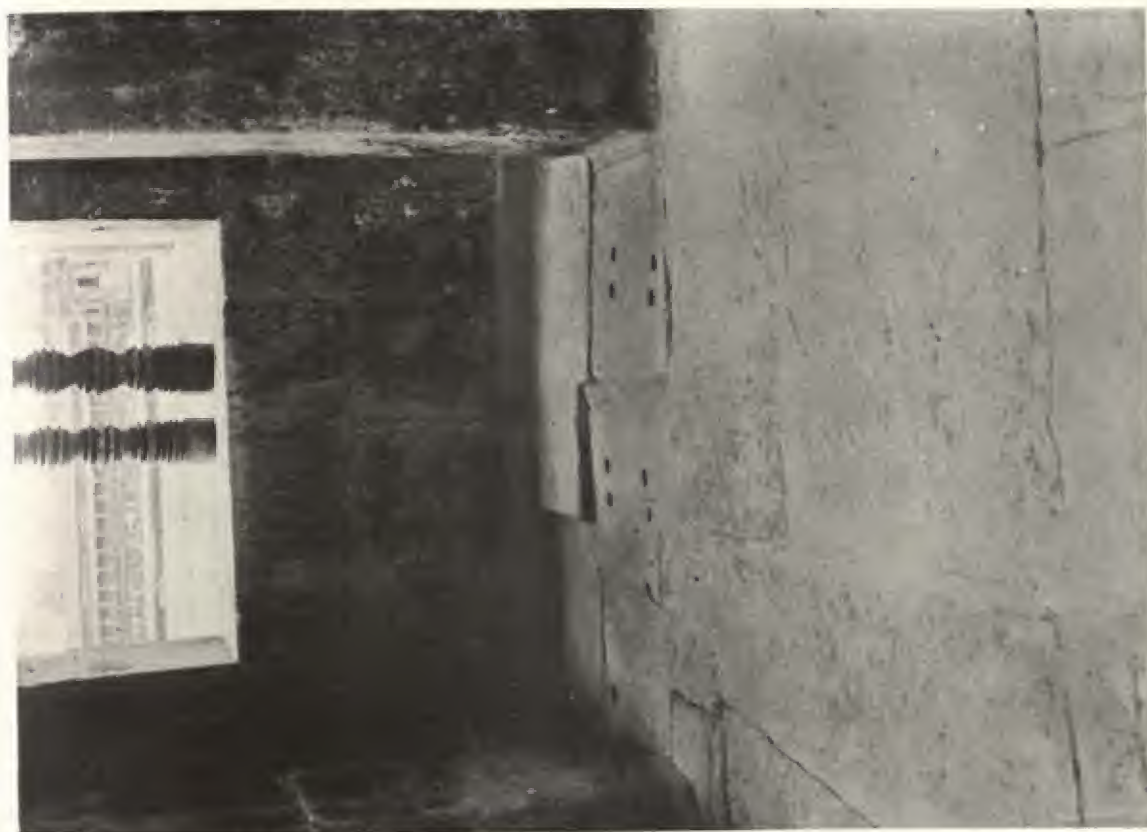
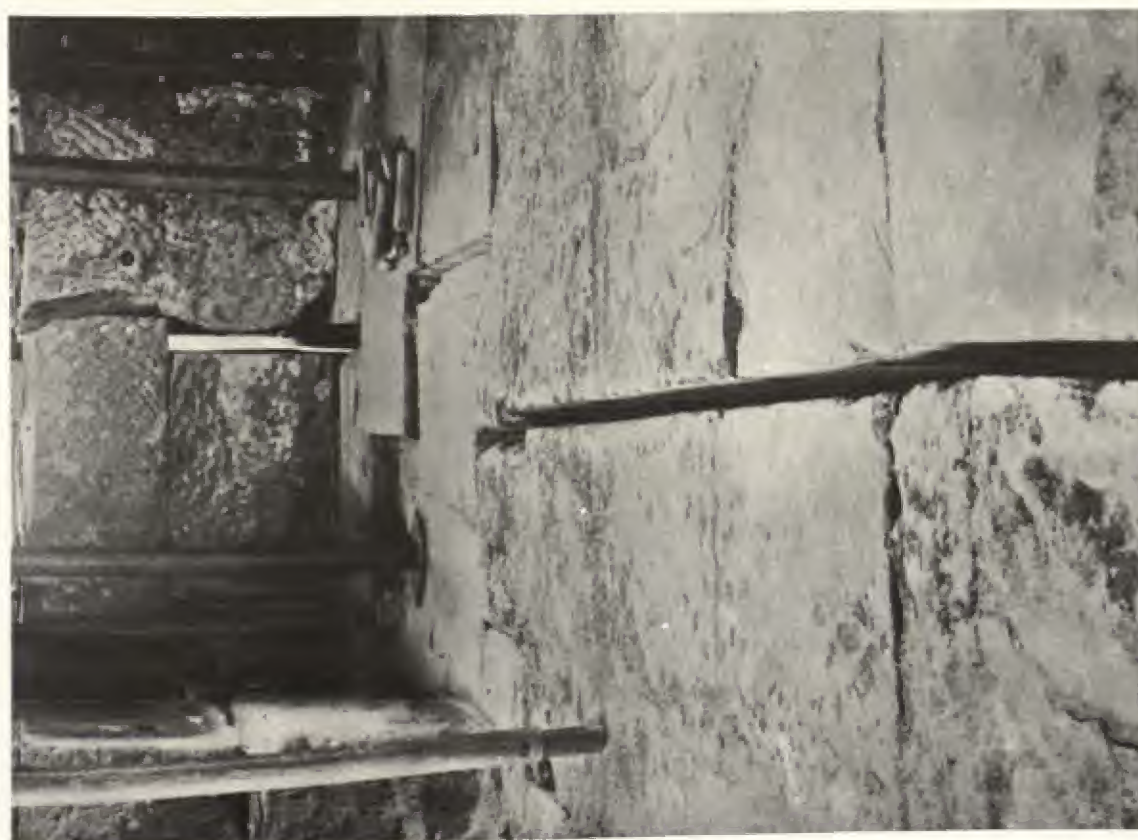
Northern Library : flooring, A, before and B, after conservation

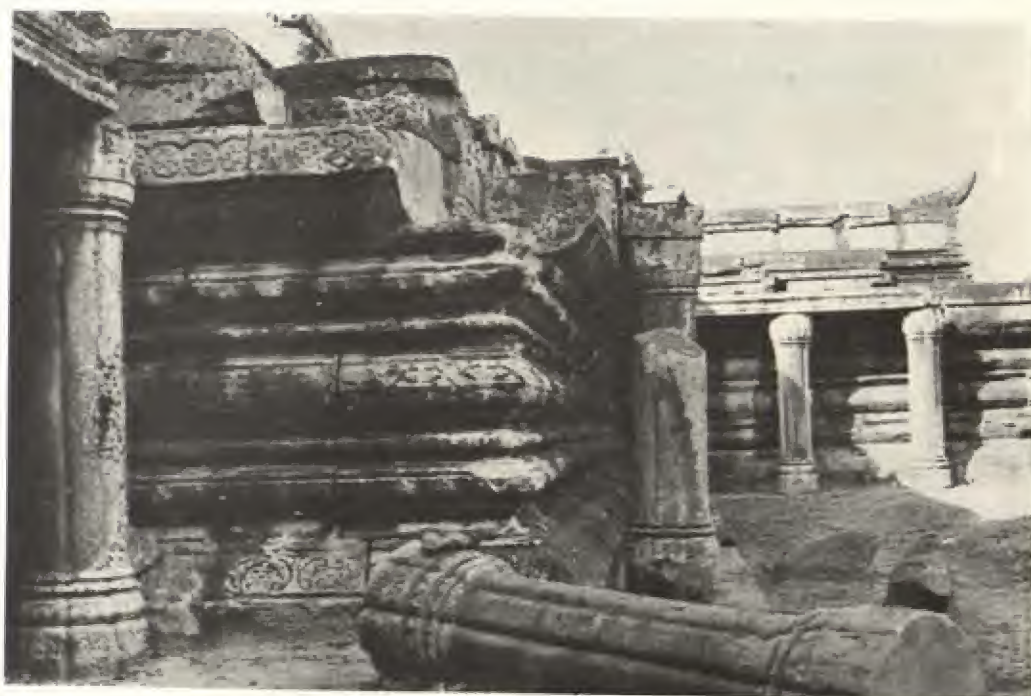
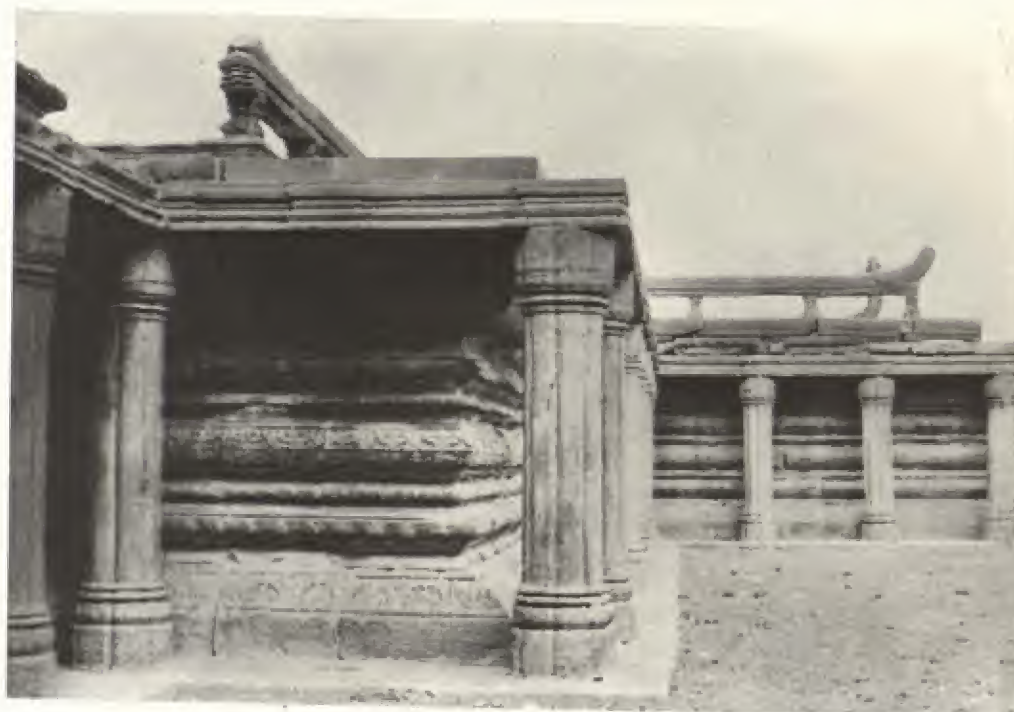
Esplanade (Ranga-Mancha): north-eastern portion, A, before and B, after conservation

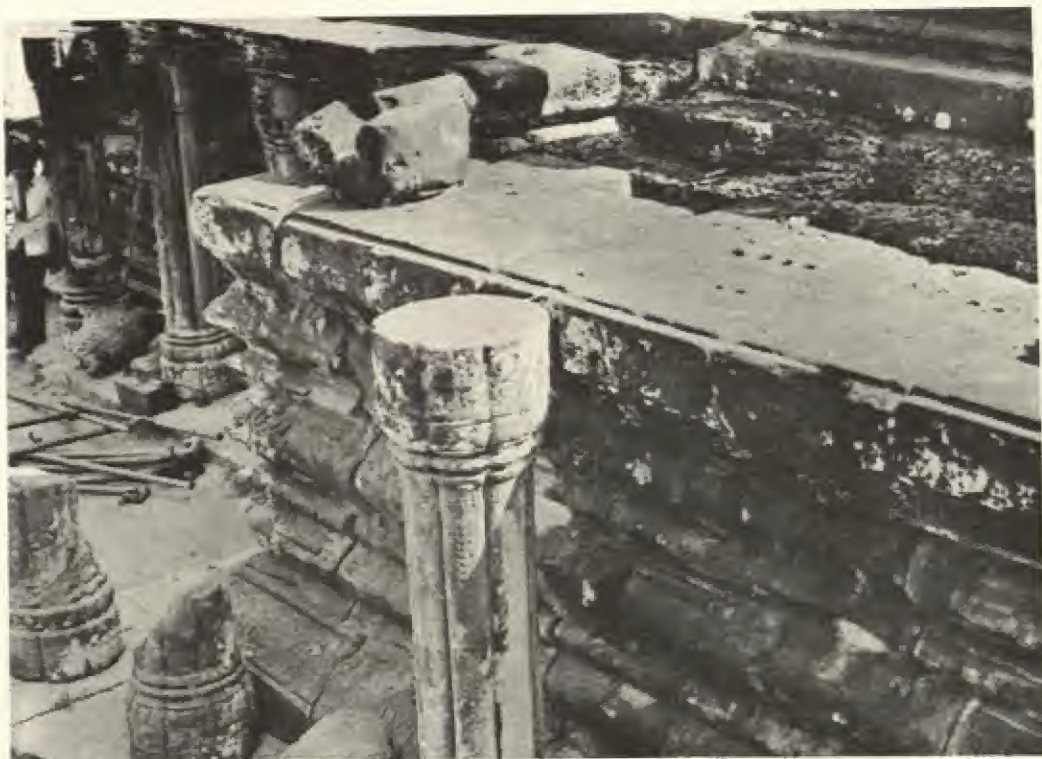
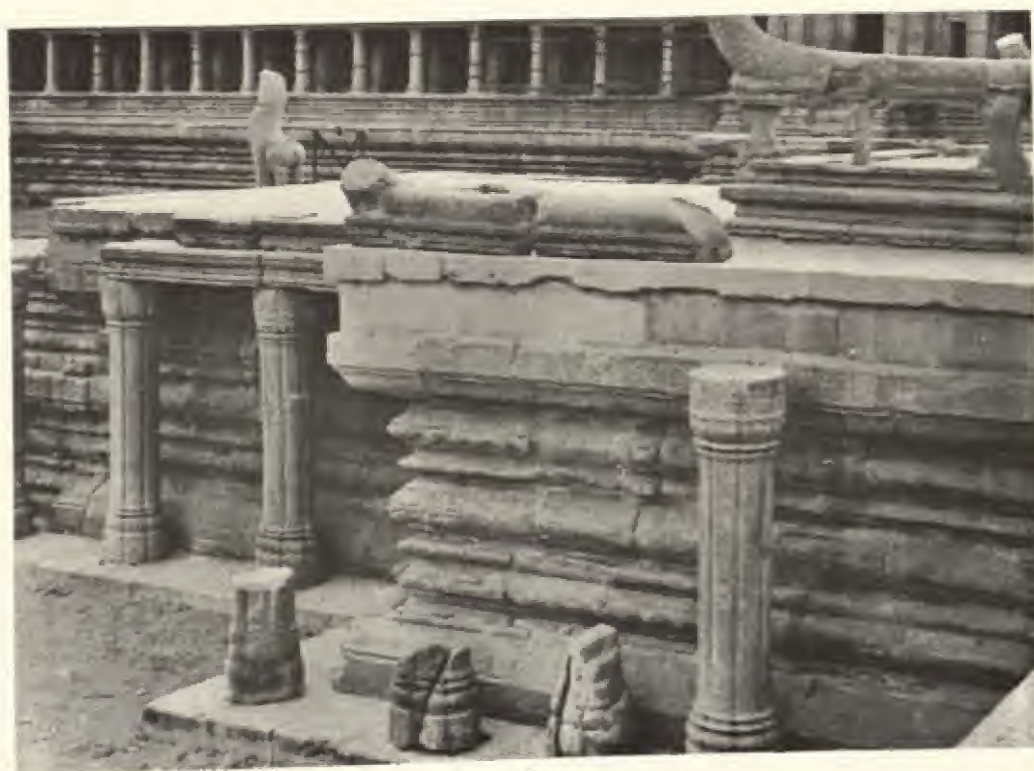
Esplanade (Ranga-Mancha): north-eastern portion, A, before and B, after conservation

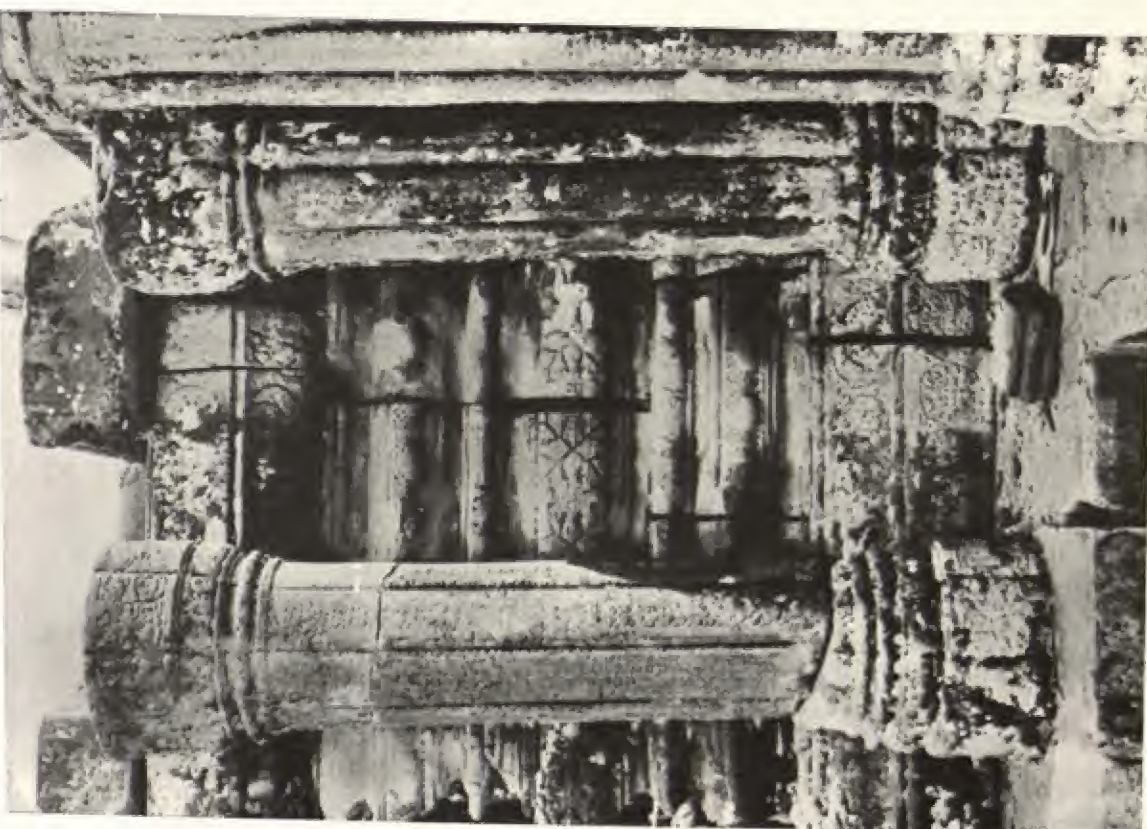
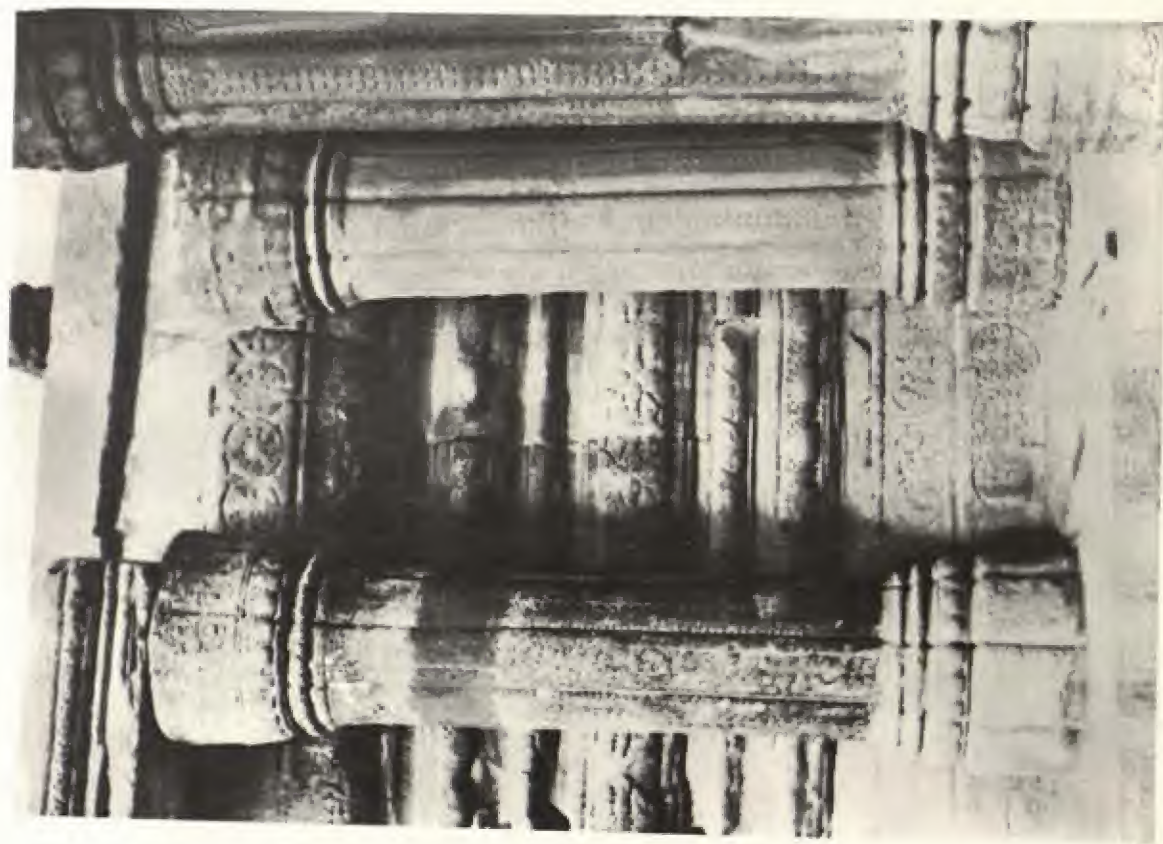
Esplanade (Ranga-Mancha) : north-western portion, A, before and B, after conservation
